# **Test of ROV-based harvesting methods for sea urchins and scallops**

## **Part Two: Report on Scallop (stort kamskjell) collection trials**

Report no:  
30/2012

7 November 2012

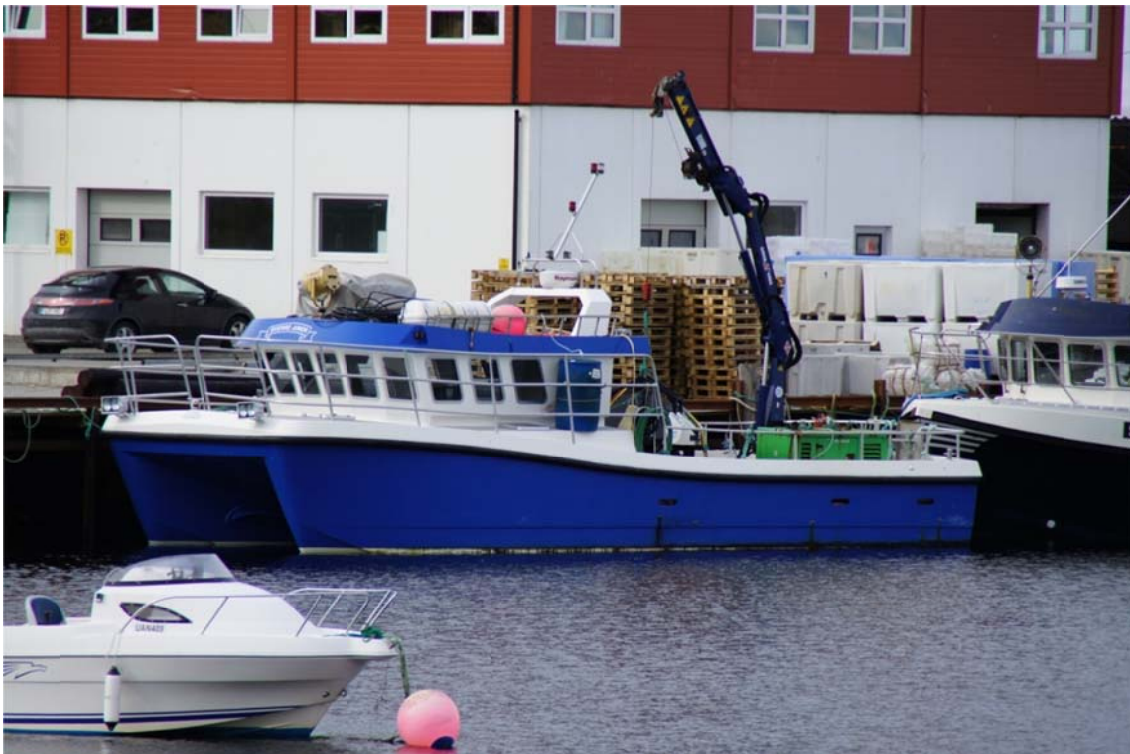
The vessel used in the Trials 1 and 2 was a 13m catamaran dive boat (Sverre Junior) (Figure 2). The vessel has a crane in the centre of the rear deck which can be used for launching and retrieval of the ROV. The crane was also used to set and retrieve the single anchor which was used to hold the boat in position. The boat is owned and operated by Frøya Dykkeservice AS. The company owns and operates a Sub Fighter 7500 ROV and the skipper/crewman/ROV driver (Rune Myrseth) has extensive experience using a Sub Fighter 7500 ROV for aquaculture inspections and fish cage cleaning. Therefore, he is very familiar with the handling of the ROV from this vessel.

Figure 2 The Sverre Junior used in Trials 1 and 2 at Frøya.

The boat used in Frøya (*Sverre Junior*) to operate the ROV was a purpose built catamaran for operating a similar sized ROV and was very efficient. This highlighted the importance of having a suitable boat to operate the ROV. During the urchin collection trials made in January 2012 the larger boat that used was extremely difficult to anchor and maneuver and the higher sides of the vessel made launching and retrieval of the ROV much more difficult.

The vessel used in the scallop trial 1 and 2 had a similar anchor system (a single anchor lifted over the side of the vessel using the deck crane). However, being a catamaran it was very stable during this operation. In situations where there were strong wind and current a double anchor (front and back) operated by a winch would allow for easier and more secure and stationary anchoring. If the boat is held stationary, regardless of current and wind, this would also allow for optimal use of the ROV.

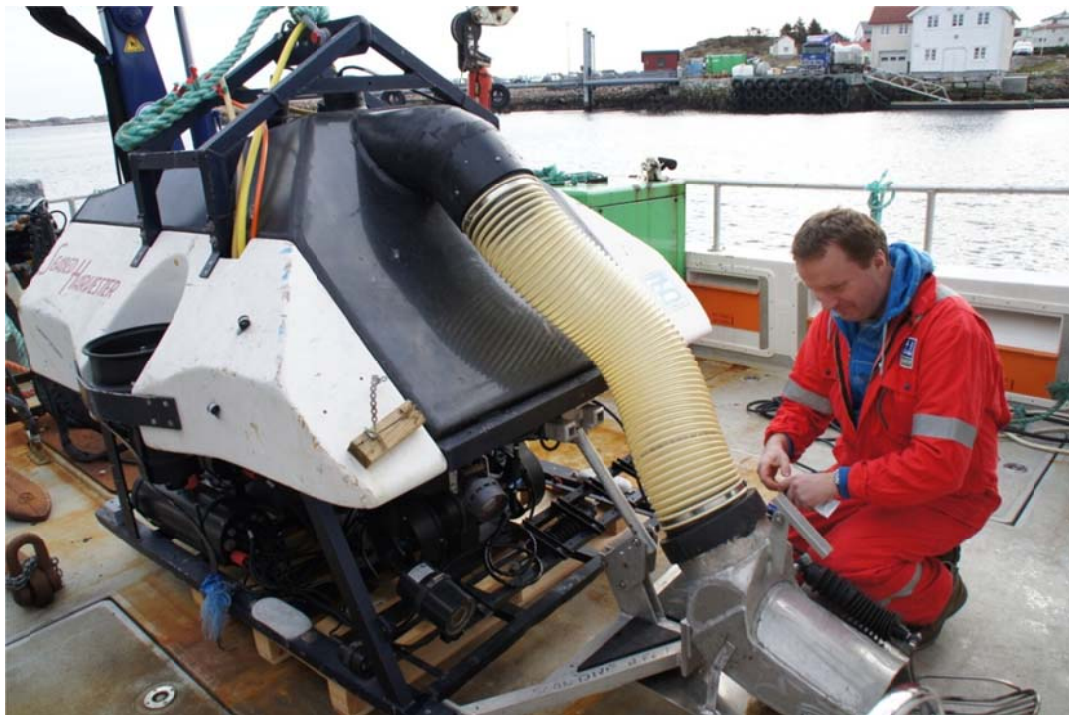
The SeabedHarvester ROV (Figure 3) used throughout this study is a specifically designed ROV for collecting benthic species such as sea urchins and scallops. It is a modified Sub-fighter 7500 ROV (165cm long x 96cm wide x 110cm high, 460kg, running off single phase 230 VAC power source) with a control unit (including monitor: 96cm long x 53cm wide x 63cm high), a remote control unit and a transformer unit. The ROV has been modified with the addition of a suction nozzle that protrudes from the front and is the point of collection. This nozzle is then connected to a storage tray which slots into the main body of the ROV (capacity approximately 100kg). A thruster creates the suction required to suck scallops from

*Figure 3 Are Hofstad (CEO of 7S-Technology AS) preparing the SeabedHarvesterROV prior to the trials at Frøya.*

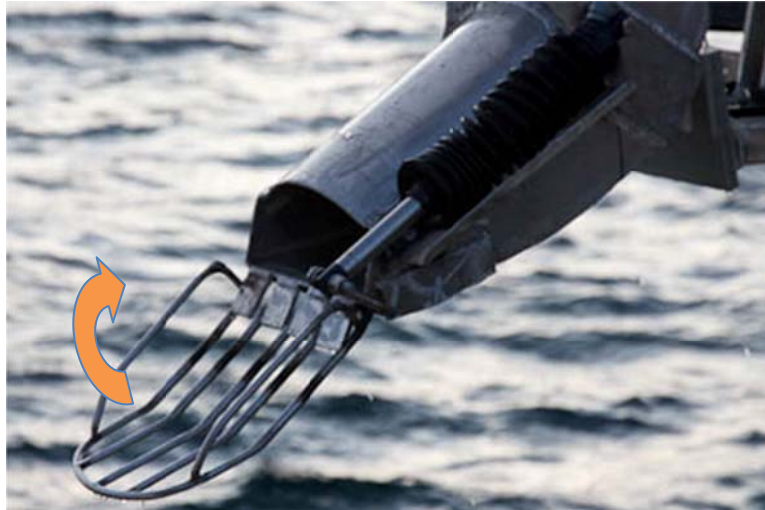
*Figure 4 The modified extension on the ROV suction tube designed for collection of scallops. The steel rake is designed to pick up the scallop and tip upwards (as shown by the orange arrow) to bring the scallop into the range of the suction from the tube.*

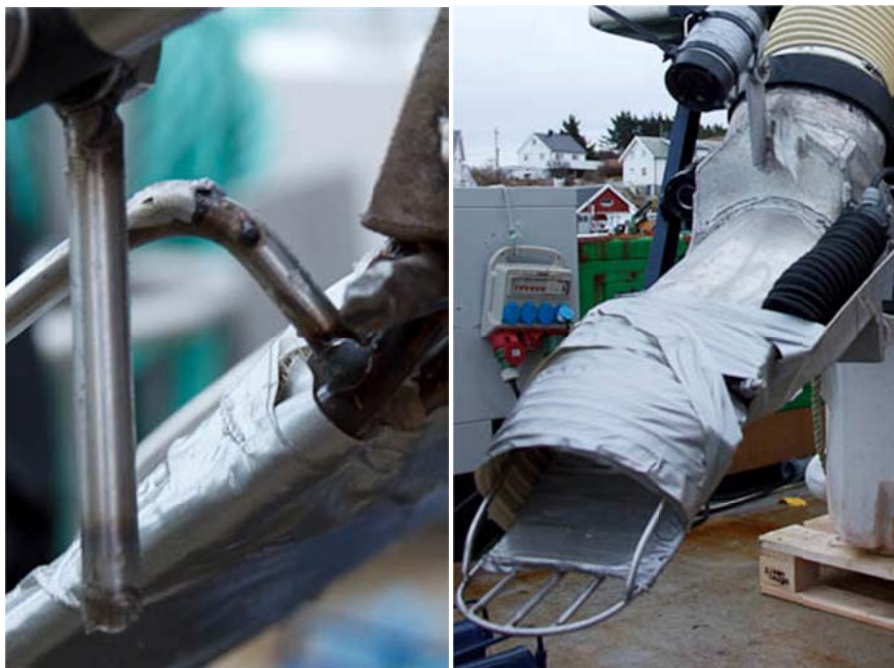
Figure 7 Broken welding and repair (second modification in Trial 1).

Following these modifications another test was conducted. In this test the ROV was driven very carefully (backing it out of stuck-in-the-sand situations instead of using forward thrust). This approach worked initially but the ROV once again got stuck and broke (due to it having too much speed when going into catch a scallop). After this second setback the vessel returned to shore.

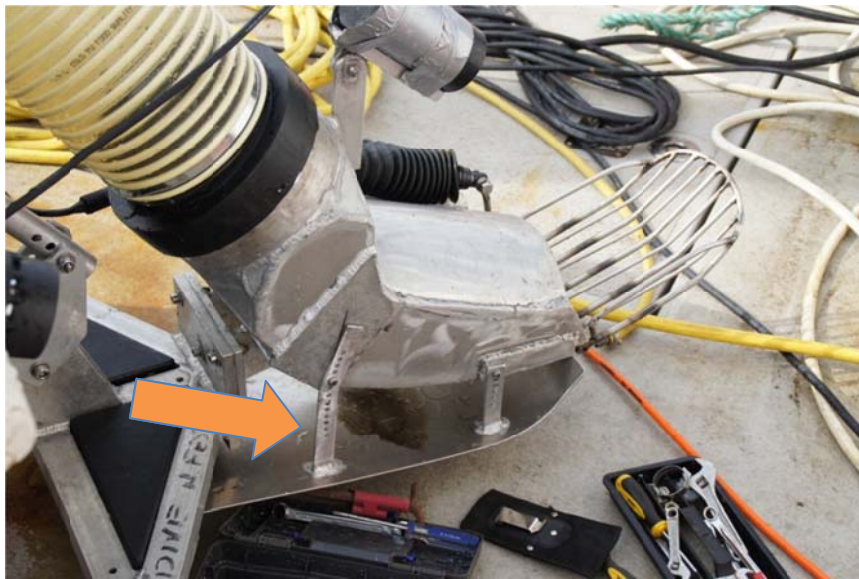
The modifications to the collection system (rake) recommended at the conclusion of Trial 1 were made to the ROV. These consisted of adding a skid onto the bottom of the collection system so that it could not dig into the sand (Figure 8). After this modification was complete the ROV was returned to Frøya for the second fishing trial (NB: the ROV was used to fish sea urchins in Båtsfjord inbetween Trials 1 and 2). On 26<sup>th</sup> April the ROV was reloaded on the Sverre Junior which returned to the same fishing spot described in Trial 1. There was an immediate improvement in catch rates (Table 1 and Figure 9) with the skid stopping the tendency of the ROV to nosedive.

*Figure 8 The modified collection system (rake) with a skid attached underneath (shown by orange arrow) to avoid the ROV nose diving into the sand.*

The modifications made to the ROV during and between trials also dramatically increased the efficiency of collection. The addition of the skid to prevent the front rake digging into the sand was the most important modification. It may be possible to increase the efficiency

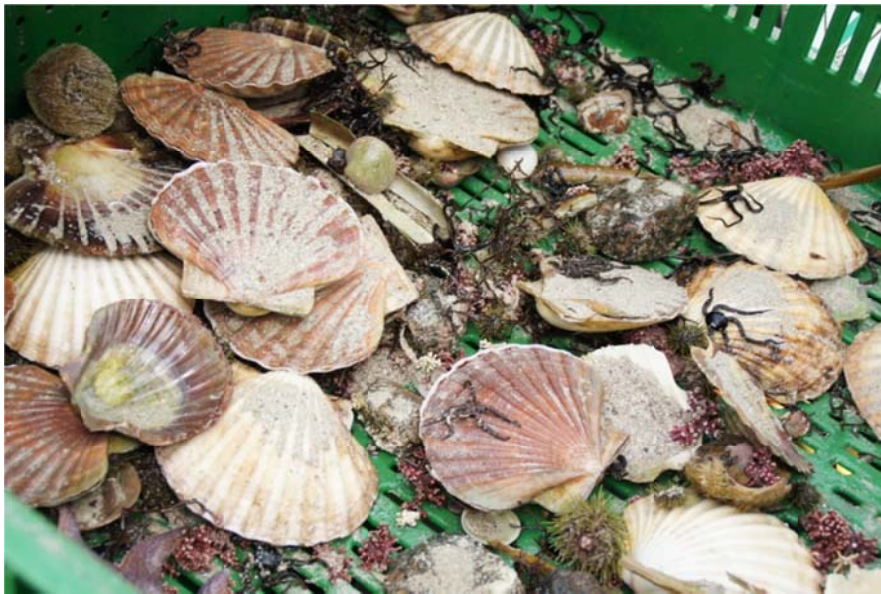
*Figure 9 Scallops in the storage tray on 26<sup>th</sup> April.*

During the testing on 26<sup>th</sup> April a number of scallops collected by ROV were photographed as they were removed from the catch tray (Figure 9) and later in the day a number of scallops that had been collected by divers and were being held in the live storage facilities at Seashell AS were photographed to compare the shell damage in each (Figure 9, 10 and 11).

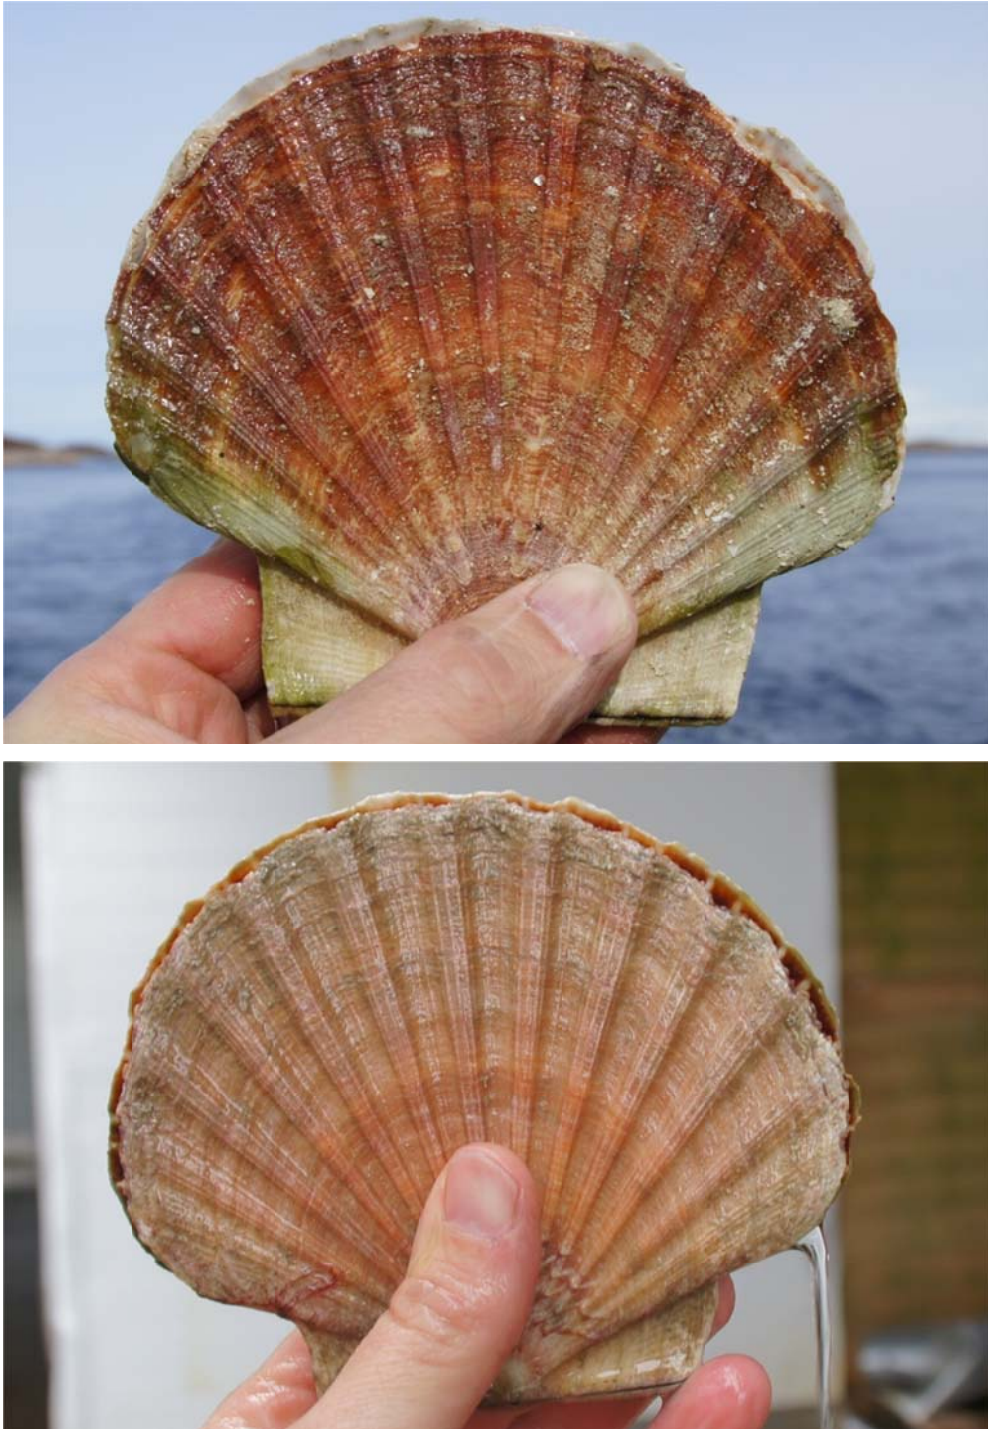
*Figure 12 A close up comparison of the condition of the bottom shell of a scallop fished using the ROV (top) compared to hand collected by divers (bottom).*

One of the marketing strategies of Norwegian companies in Frøya (eg Seashell AS) is to promote their scallops as being handpicked and in excellent condition. A visual comparison was made between scallops collected by the ROV and scallops collected by divers for Seashell AS (Figures 10, 11 and 12). The results show there was slightly more chipping on the growing edge of the scallop in the ROV collected scallops but the authors believe it would be very difficult to identify scallops collected using the two different techniques.

There were no obvious differences in shell quality in scallops collected by ROV compared to scallops that were handpicked by divers.

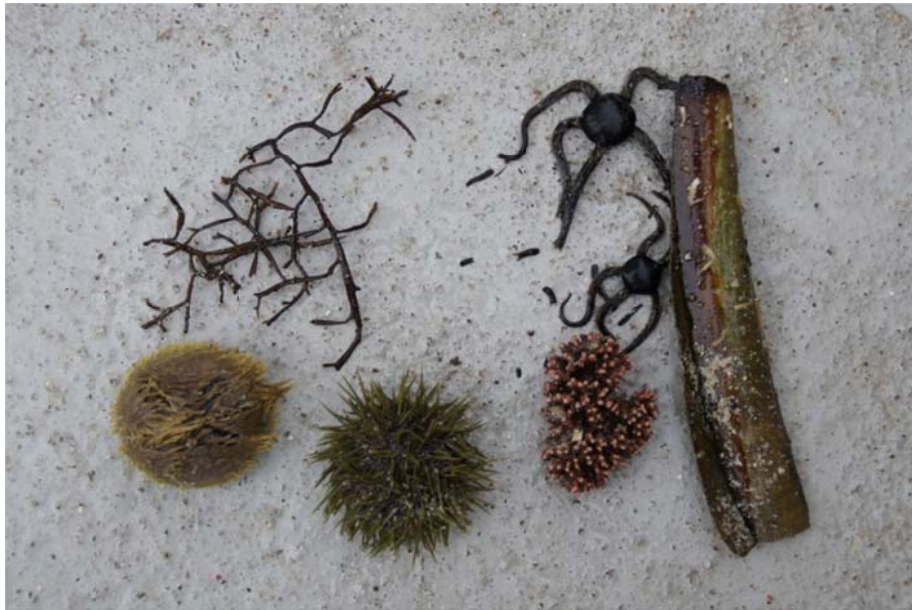
During the collection trials 1 and 2 the bycatch made up approximately 20% of the total catch. Figure 13 shows the typical bycatch from this area which primarily consisted of echinoderms such as sea stars, sea urchins and sea hairs, algae, soft coral and empty razor shells. It is likely that the bycatch will change significantly depending on the area where fishing occurs. Because the Trials 1 and 2 were conducted in a shallow area, close to the seashell facility where scallops are often dropped and stored the fauna and flora at this site is

*Figure 13 The typical bycatch at the Frøya collection site consisting of echinoderms (sea urchins sea stars and sea hares), coralline algae, algae and empty razor shell.*

The flora and fauna found at the test area used in Frøya is not atypical of the areas that are normally fished for scallops as it is a shallow site used to temporarily store scallops. Subsequently, there was an abundance of small echinoderms (particularly sea urchins) and algae. These items made up approximately 20% of the total catch at this site. None of the

species collected as bycatch were damaged, or had any economic or conservation significance and were simply returned to the sea after capture. The authors believe that the level of bycatch would decrease significantly at most scallop collection sites as these sites would be deeper with a much less varied biota. The results in the 3<sup>rd</sup> trial in Helegland showed there was a very small bycatch consisting of only a few species. The bycatch consisted of 'kuskjell' (*Arctica Islandica*), a few starfish, a very few 'o-skjell' (*Modiolus Modiolus*), and some algae. Both the kuskjell (clam) and the oskjell (mussel) could be of commercial interest as they are both consumed as food.

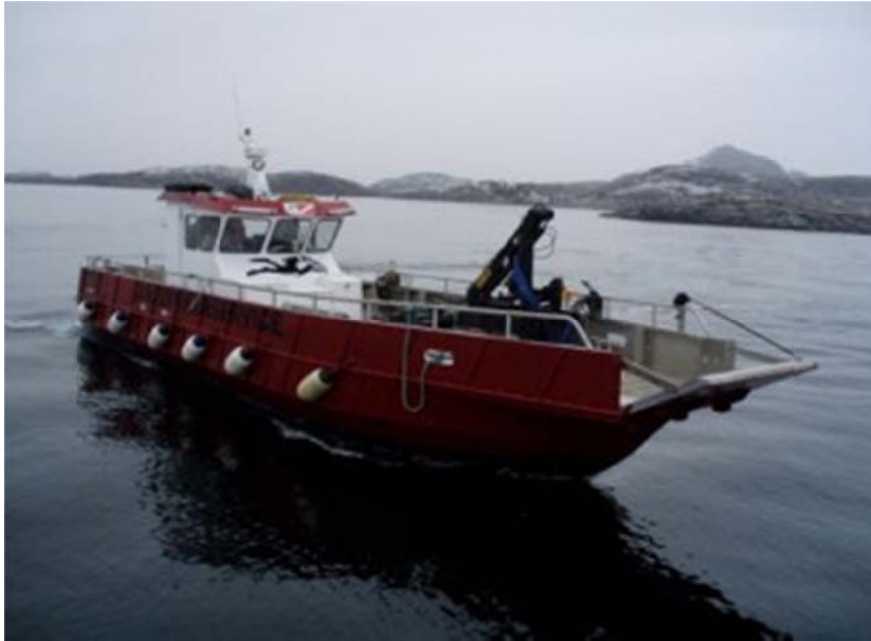
The vessel used in Trial 3 was a 50ft diving vessel “Skjærgården 1” (Figure 14), owned and operated by “JR Dykk” in Sandnessjøen. This vessel has a Palfinger crane located in the fore port side of the boat. The operation of the ROV and anchoring was conducted similarly to the trials at Frøya. This company has extensive knowledge regarding diving operations in the area and has had many years of experience in scallop diving. The ROV was operated by a professional ROV operator, Marius Nilsen, who normally works with larger ROV systems on offshore vessels.

Figure 14 The 'Skjærgården 1' used in Trials 3 at Helgeland.

The boat used during the Helgeland trial was a 50ft monohull diving boat with a water jet system which made it very fast and possible to reach remote locations in a relatively short time. As in the previous trials the boat also used a manual anchoring system which is not recommendable for this type of operations as the location must be changed continuously. We also had to use an external power source as the boat was not equipped with sufficient power generation to operate the ROV. Although the speed of the boat was a great advantage the reduced deck area and also reduced stability compared to the catamaran were major disadvantages and should be considered when designing or choosing a boat for any future ROV operations. The results from this study indicate that for future operations, a catamaran with an automatic mooring system and a high operating speed would be optimal.

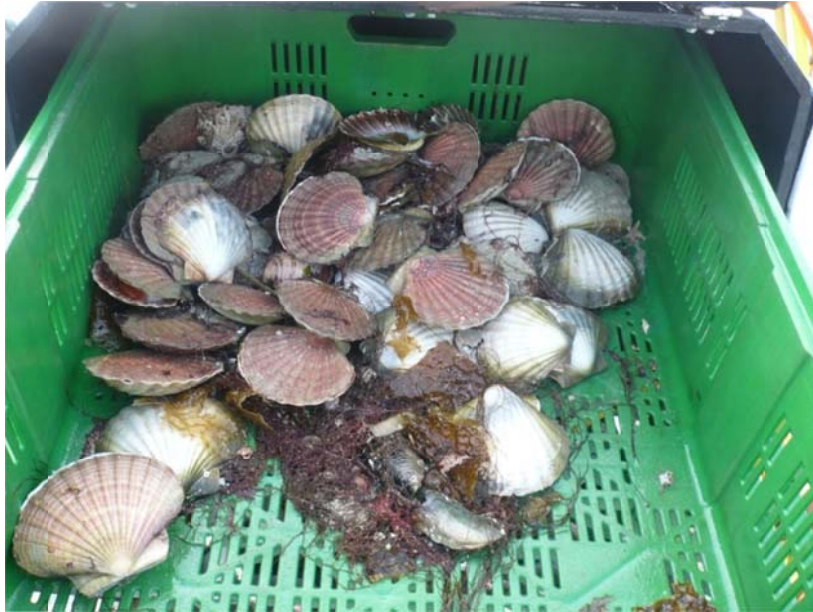
Figure 15 *Scallops in the storage tray on 26<sup>th</sup> April. There was very little bycatch present in the catch.*

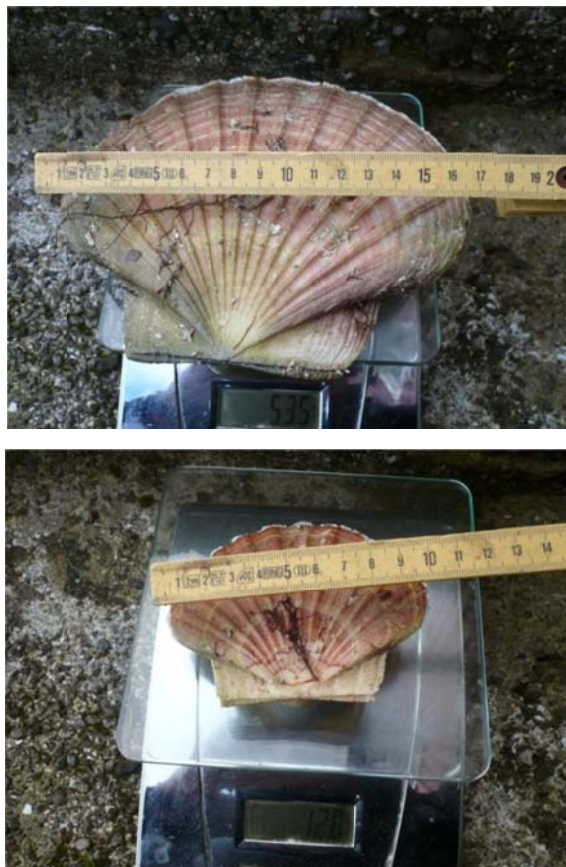
Figure 16 *The size range of scallops collected at Helgeland; the largest scallop (top) = 17 cm/535g and the smallest scallop (bottom) = 10 cm/128g. The average size of the scallops was 375g.*

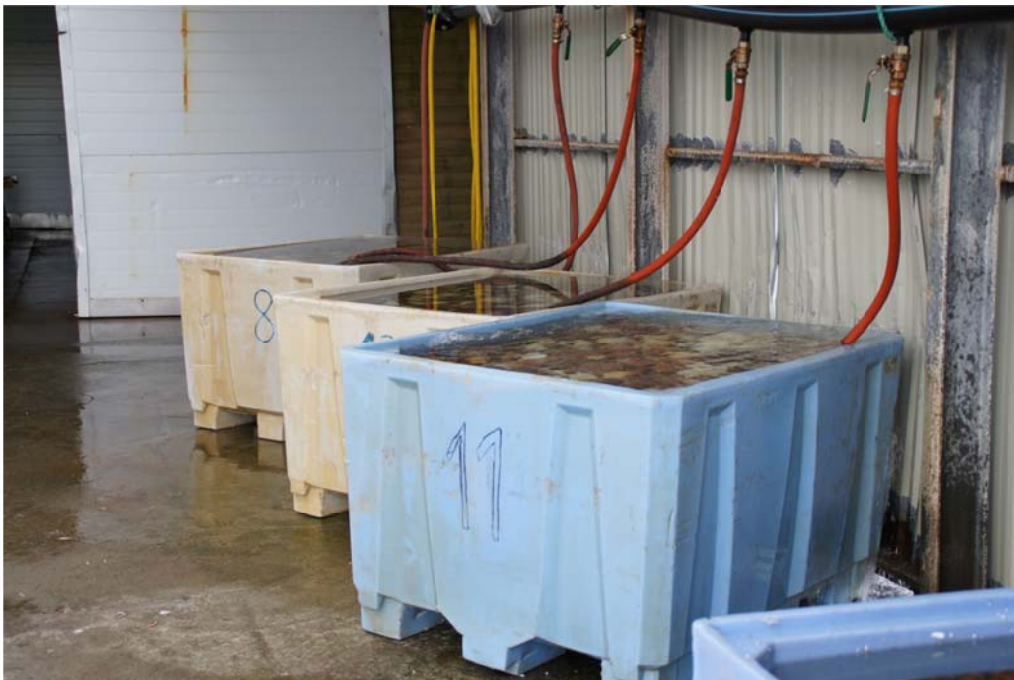
No comparison of sand ingestion by the scallops was made during the trials in Frøya. However, scallops currently collected by divers at Seashell AS are held in large plastic containers (Figure 17) which would be ideal for purging the scallops of excess sand.

Figure 17 The holding tanks used by Seashell AS to store scallops once they are landed.
