Research Cruise Report [2021825]: FV “Vikingbank” Catch Control in the Blue Whiting Pelagic Trawl Fishery.

*Mike Breen, Jostein Saltskår, Sigurd Hannaas, Liz Kvalvik, Olafur Ingolfsson
(Institute of Marine Research).*

Dagfinn Lilleng (Norwegian Fisheries Directorate).

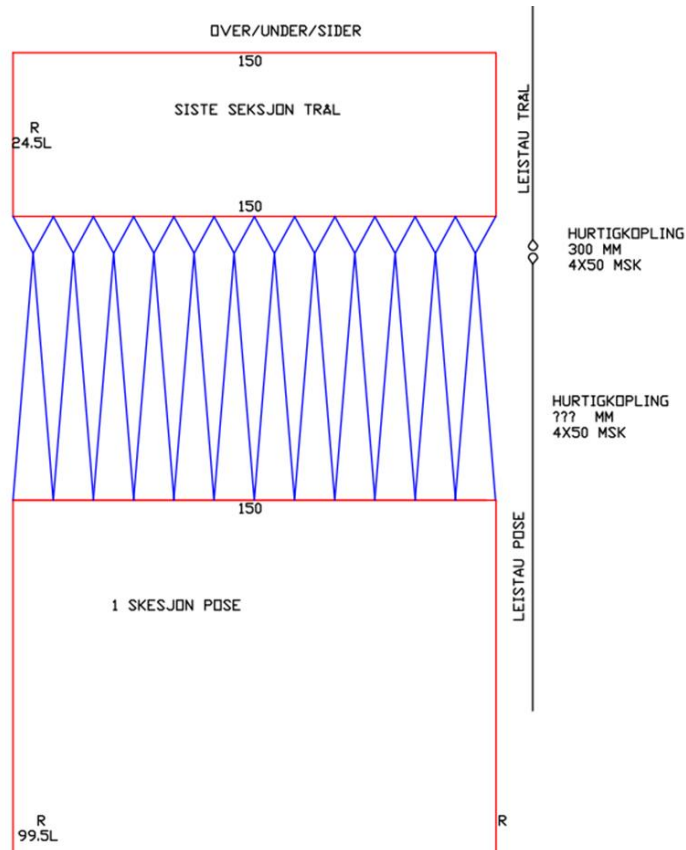
Figure 4b – Net Drawing of Catch Control Rig 2: 2.0m Meshes in all four Panels.

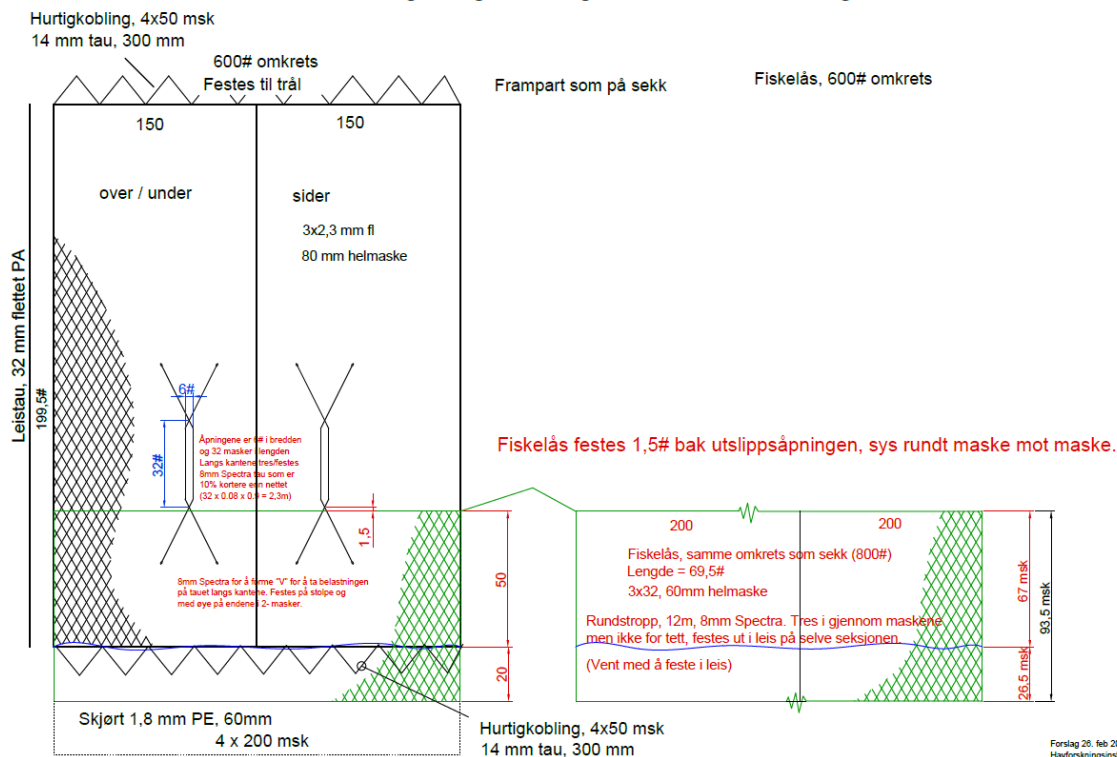
Figure 4c – Net Drawing of Catch Control Rig 3: 2.5m long slot, one in each of four Panels.

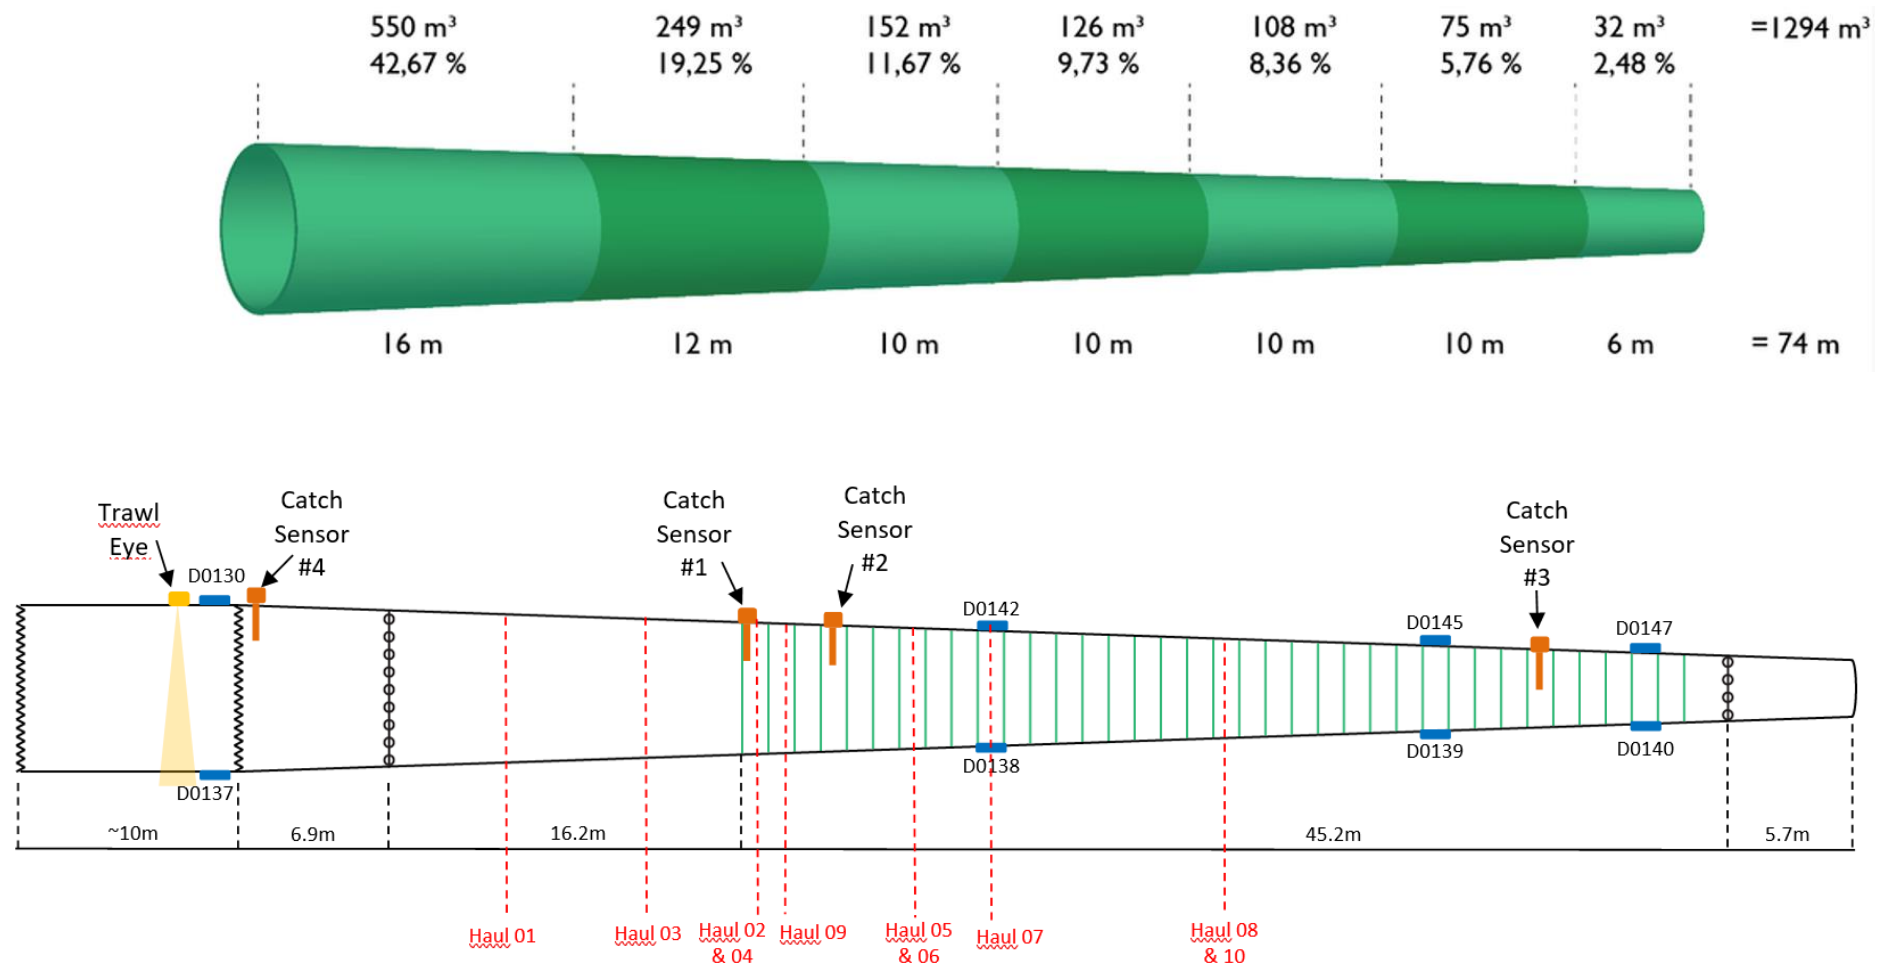
Figure 12 - Top: volume estimates for the conically shaped codend on the Vikingbank trawl [Not to scale; figure by L. Kvalvik]. Bottom: positions on the codend of the Catch Limitation Release (CLR) for each haul (in Red) (see also table 3); also shown are the relative positions of the Trawl Eye (yellow), Catch Sensor units (orange) and depth-loggers (blue) [Not to scale; figure by L. Kvalvik & M. Breen].

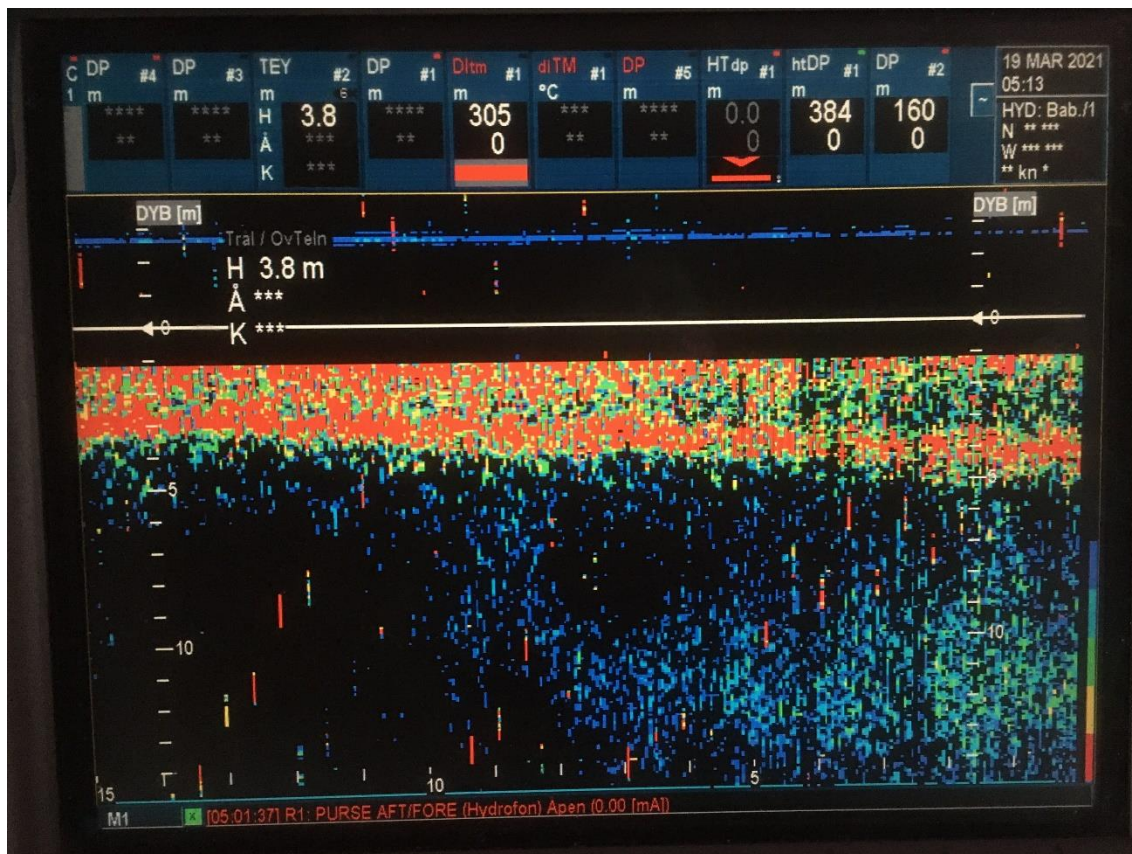
Figure 14 - Haul 09 [1653] View of Trawl-Eye screen, 2 minutes before starting haul-back. Indicators in this image that suggest the catch limit has been reached include: consistently strong (red colouration) signals at top of screen suggest there are high densities of fish inside the CCR; the diameter of the CCR appears to be increasing, as its lower boundary moves further down from the top of the screen; and increasing frequency and strength of signals from beneath the CCR suggest fish are beginning to escape from the lower release opening. [Note – screen shows 15 minutes of echosounder data, with most recent signals displayed to the right].

with indications that catch was escaping from the CCR, was taken as a definitive signal that the catch limit had been reached. However, on three hauls (04, 05 and 07) haul-back was started before a positive consistent signal had been received from catch sensor #4, because the Trawl-Eye indicated that high densities of fish were accumulating in the CCR (hauls 04 and 05). Further video analysis is required to confirm whether these indicators are true signals that the catch limit has been reached, and whether they correlate with increased escapes at the escape openings.

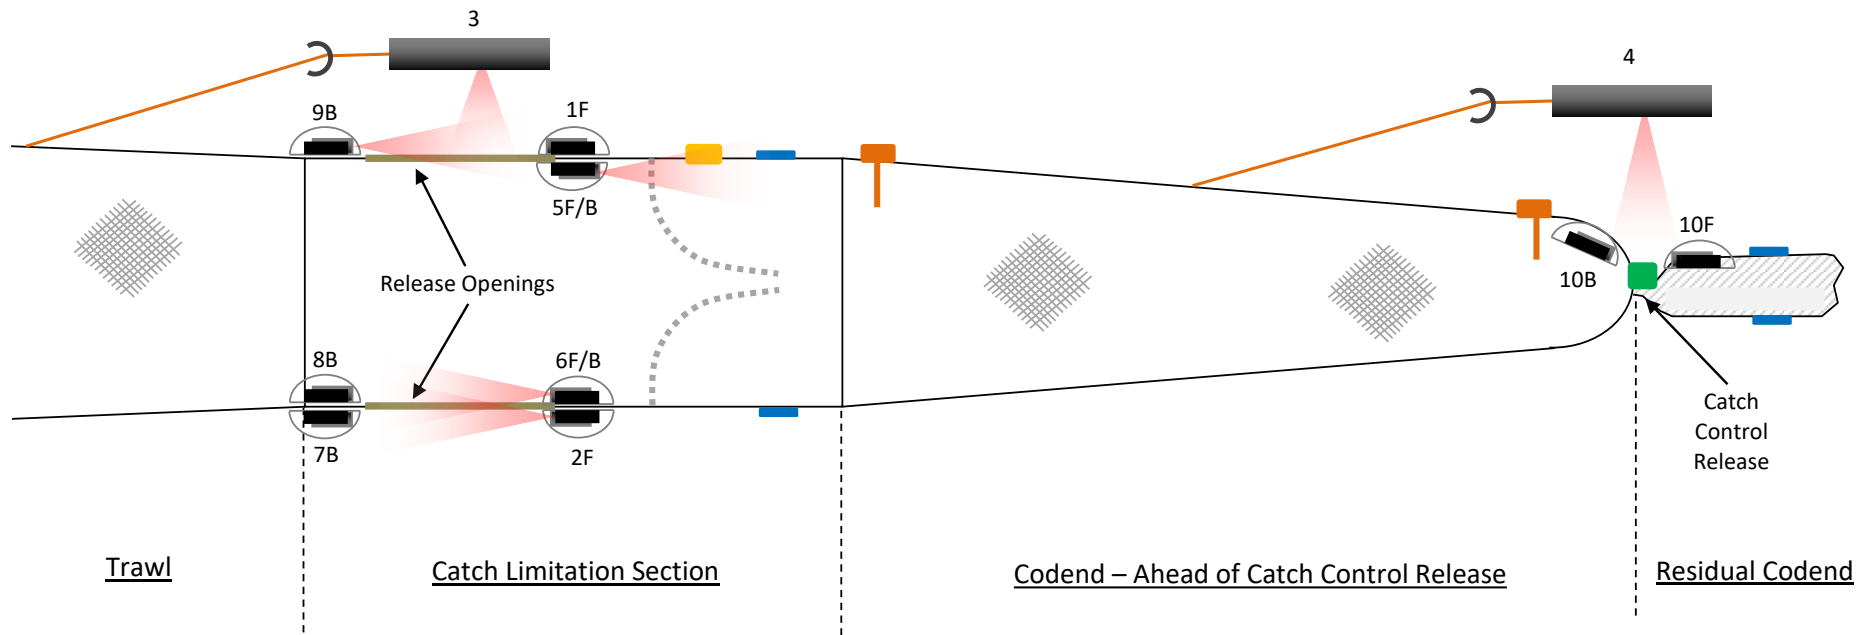
Figure A4 – Camera positions on the Catch Control Rigs and Codend. Post-script F means the camera was forward facing (toward the mouth of the trawl) and post-script B means the camera was backwards facing (towards the codend). The red shaded triangles provide an approximate indication of the illuminating light field in some example positions. See figures 4 and 12 for further explanation of the fishing gear components.

Having multiple perspectives at the same time can be very informative and synergistic when interpreting complex operations, like the catch control processes described in this report. For example, a sudden increase escape rates at position 1F, may be explained by an increase in fish density at position 5F; which in turn could be explained by either an increase in density at 6B, as the codend fills, or because of a failure in the fish lock during hauling. It is recommended that future work in this project should utilise multiple and synergistic camera positions in each haul to answer specific pre-determined research questions. This will require a substantial increase in the camera and light equipment required for each cruise (see comments above) to ensure coverage and redundancy. However, caution should be used not to overload one area of the net with too many cameras because this could distort the net (e.g. haul 08; positions 2F, 6F and 6B).
