Final Project Report- MICRORED

2022:01382 - Unrestricted

Microplastics,
aquaculture, HDPE
feeding pipes,
pneumatic conveying,
pipe wear, pellet
degradation

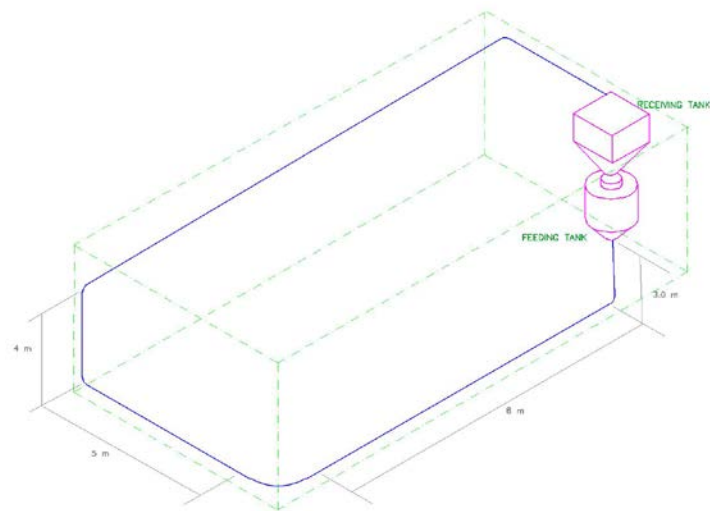
Figure 5: Schematic view of the conveying test rig (A), pictures showing different parts of the test rig and equipment (B)

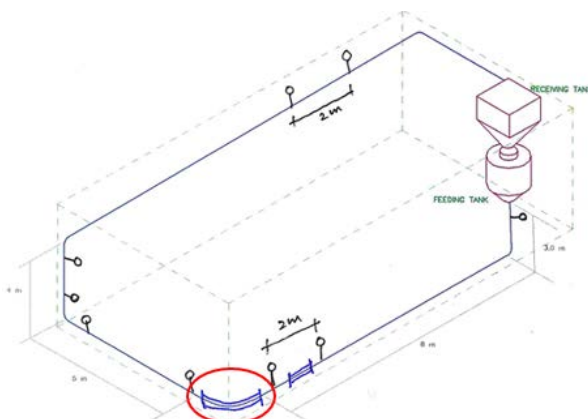
Figure 6: Erosion is studied in the 90° bend marked by the red circle.

The degree of erosion is typically measured gravimetrically, meaning the specimen is weighed before and after exposure to erodent. In this study, erosion is studied in one of the 90° bends (Figure 6) that can be detached from the pipeline and weighed before and after the tests to determine the weight difference.

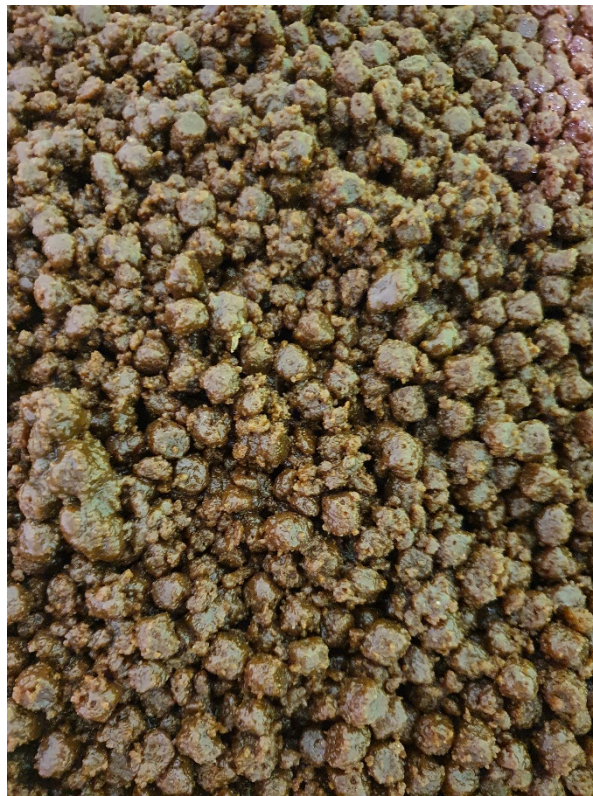
Figure 16: Degraded pellets after seven rounds of transport in the pneumatic conveying rig, the size of the pellets is reduced, and pellet debris are apparent.

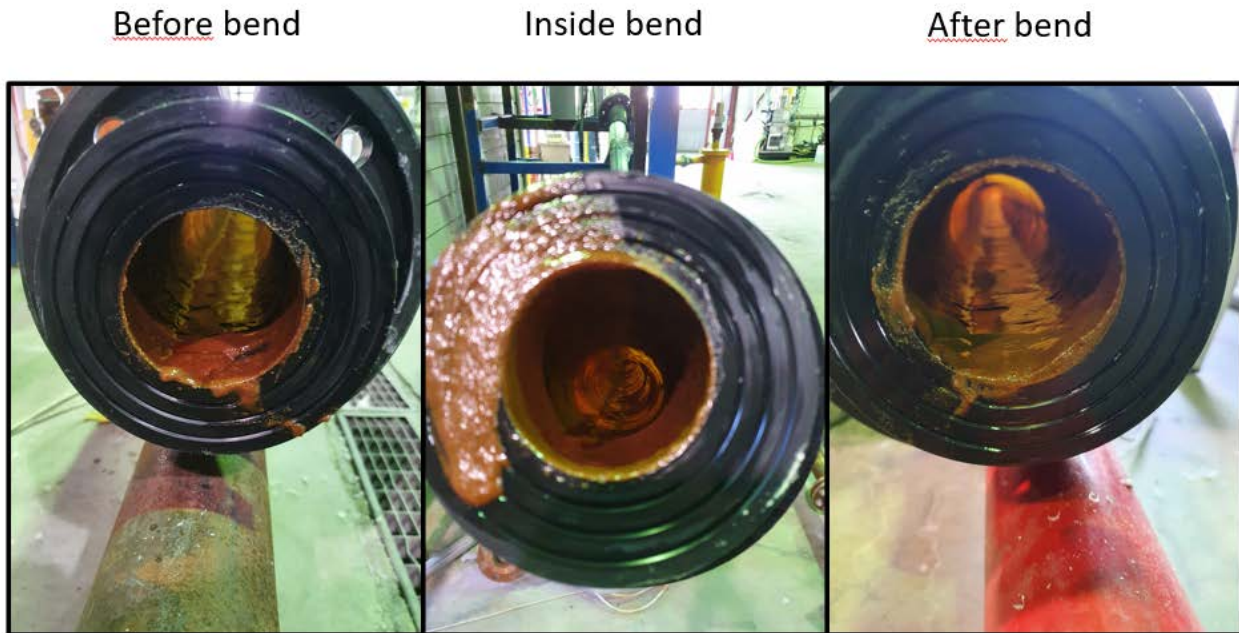
Figure 18: Oily dust deposit inside the pipeline after erosion tests.

After the last round, the bend piece was detached from the pipeline, which revealed significant amounts of oily dust deposit inside the lines and in fact, the whole pneumatic conveying system (Figure 18). Such large amount of deposit inside the lines was unexpected, though it explained the unstable conditions and the material loss in the receiving tank during the tests.

Overall, the fats layer coating occurring in the inner section of the feeding hoses during standard fish feed pellet distribution (fig.18) may play an important role in explaining the observed plastic fragments size distribution in the addressed samples.

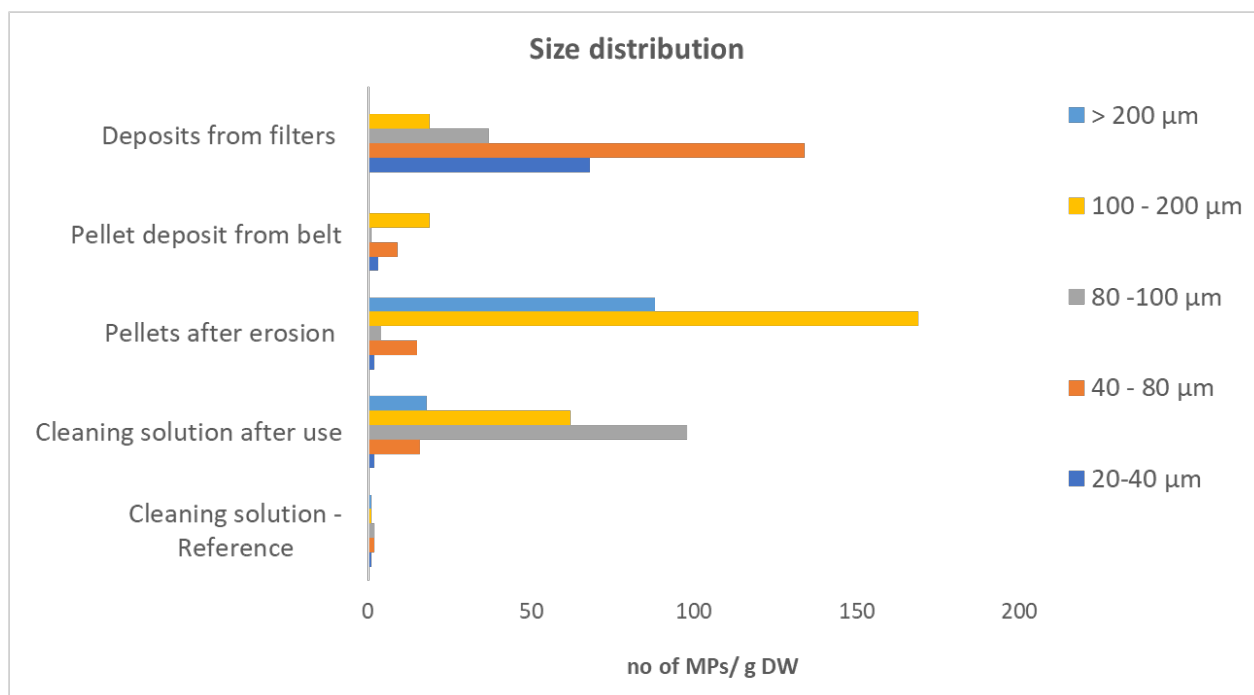
Figure 26: Relative size distribution of plastic fragments in the analysed samples from the convey system experiment.

Furthermore, the particle size distribution analysis of the investigated samples from the convey system experiment showed informative results. If the material deposited in the filter showed a size distribution toward the smaller particles. An opposite distribution prioritizing larger fragments is observed in in the pellet

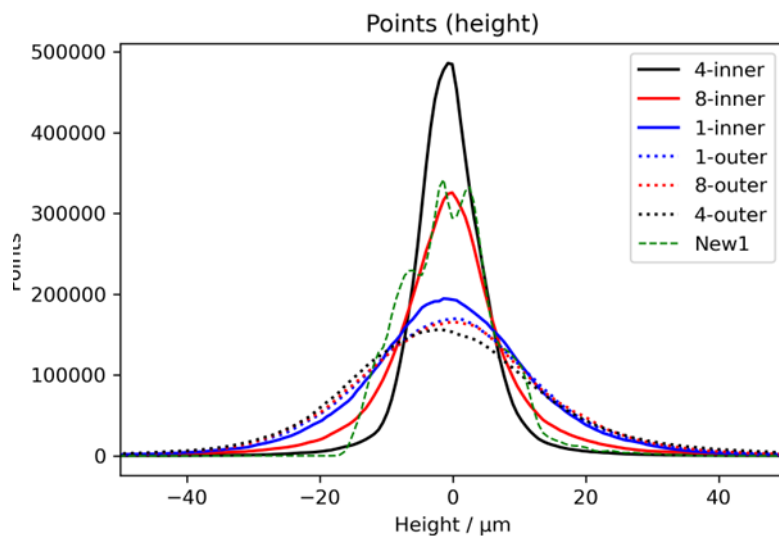
Figure 37: Height distribution of individual pipe segments

The roughness of the inner wall was determined by the statistics of the detecting points in the investigated specimens. The dashed line in Figure 37 indicates the height distribution of the inner wall of virgin pipe. It is clear that the inner wall of new pipe is not 100% even, with 3 height peaks corresponding to the stripes along the pipeline induced by the extrusion process.
